Intel® Pentium® 4 Processor

Specification Update

October 2003

Document Number: 249199-042

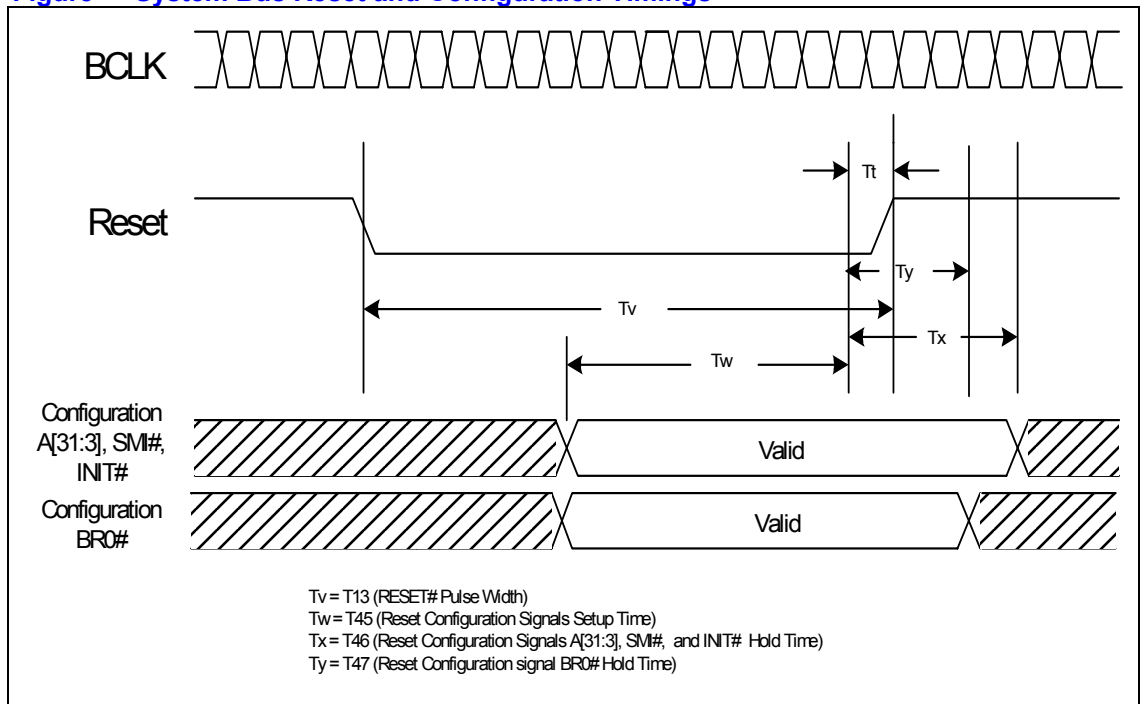
Figure System Bus Reset and Configuration Timings

The BR0# maximum hold time has changed to 2 BCLKs. This change will be shown in the “System Bus AC Specifications (Reset Conditions)” table and “System Bus Reset and Configuration Timings” figure of the *Intel® Pentium® 4 Processor with 512-KB L2 Cache on 0.13 Micron Process EMTS* and *Intel® Pentium® 4 Processor in the 478-pin Package Electrical, Mechanical, and Thermal Specifications (EMTS)* and *Intel® Pentium® 4 Processor in the 423-pin Package Electrical, Mechanical, and Thermal Specifications (EMTS)*. These changes will be incorporated in the next revision of the EMTS (Datasheet).

The following figure will be modified to reflect this change:
